Innovations for Navigation Projects Research Program

Prototype Barge Impact Experiments, Allegheny Lock and Dam 2, Pittsburgh, Pennsylvania

January 2003

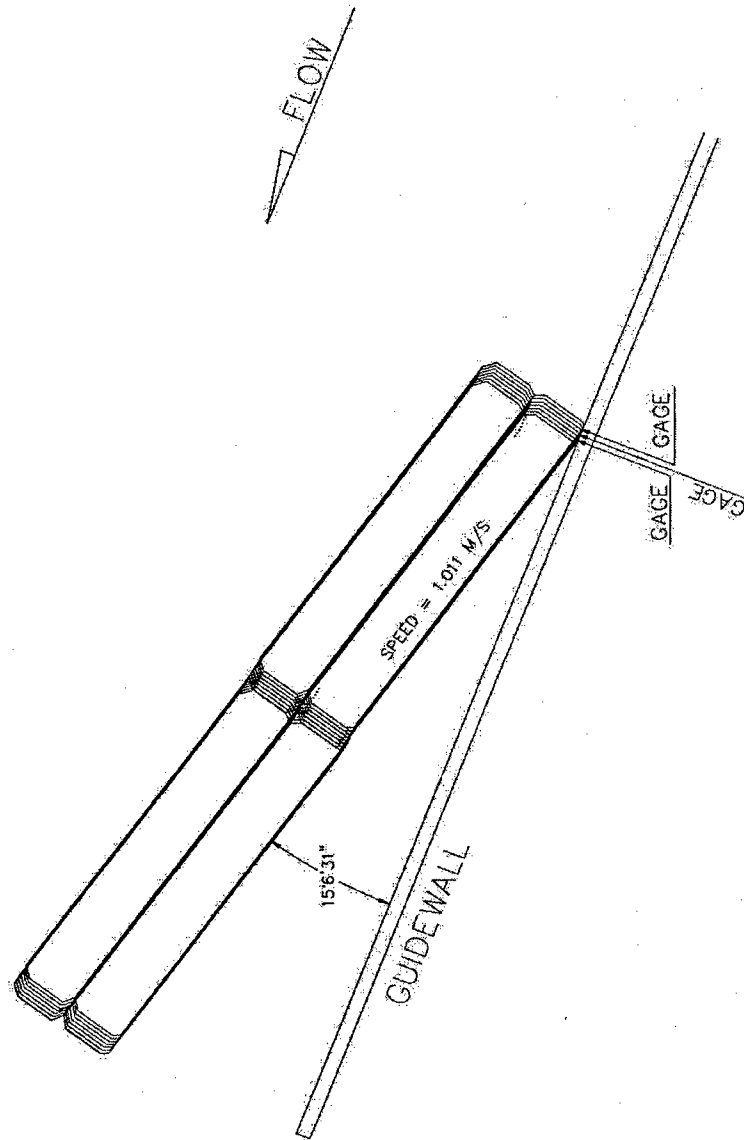
BARGE IMPACT STUDY
AT LOCK AND DAM 2
ALLEGHENY RIVER
BARGE ANGLE / SPEED
RUN 32 OF 36
BUMPERS IN PLACE

LEGEND:
NOTE: BARGES LOADED TO 8.5 FT DRAFT
ANGLE, SPEED, AND POINT OF IMPACT
MEASURED USING GPS SURVING TECHNOLOGY
ALL MEASUREMENTS ARE IN METERS
